LIGHTNING INJURIES IN AN ICE CAVE IN THE AUSTRIAN MOUNTAINS

Gerhard DIENDORFER

Wolfgang SCHULZ

**Austrian Lightning Detection & Information System
(ALDIS), Kahlenberger Str. 2b/3, A-1190 Wien**

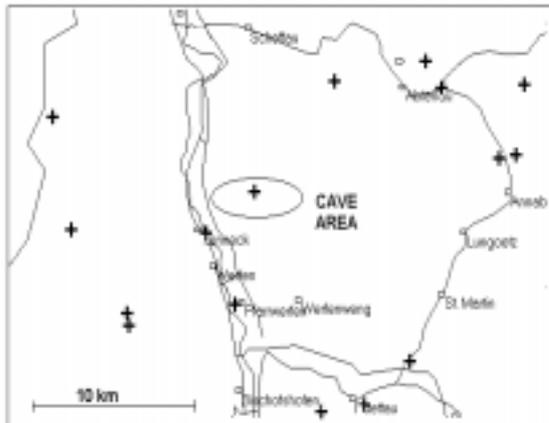
Fig. 1: Lightning activity in the region of the ice cave (+ are the flashes located by the Austrian Lightning Detection & Information System ALDIS)

The lightning location system ALDIS reported a flash in the cave region at 12:30:26 local time with an amplitude of 9 kA. Because there is no exact time reference for the accident, it is unclear whether this "small" flash caused the injuries or the location system missed the actual flash responsible for the accident.
