Examples of severe destruction of trees caused by lightning

F. Heidler¹, G. Diendorfer², W. Zischank¹

Abstract: The paper presents two examples of trees severely damaged by lightning strikes. The trees literally burst, when the lightning current passed through the trunk. Huge fragments were blasted away from the trunk and the roots, over distances of several tens of meters. The bursts even caused considerable damage in the surroundings, e.g. removing large patches of bark from nearby trees, when hit by fragments at high speed. The data of lightning location systems revealed that the trees were most likely struck by high amplitude positive cloud-to-ground lightning.

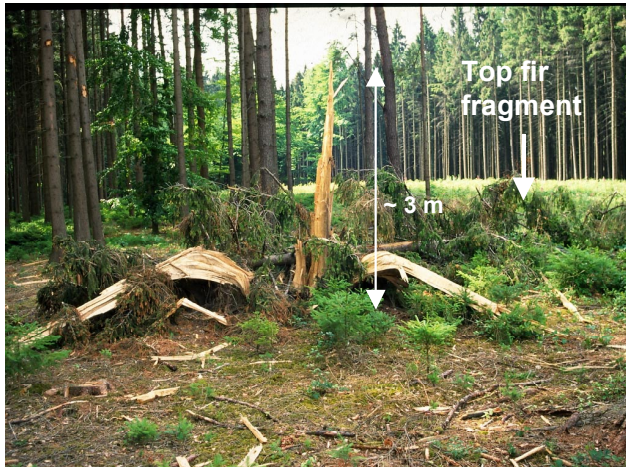
When a tree is cut, typically the top of the tree is farthest away from the stump. Opposite to that, here the top fir segment was located closest to the stump fragment (Fig. 1). The major bottom fir fragment was blasted away about 16 m and the major mid-section fir fragment more than 20 m, respectively.

Fig. 3 shows the locations of the fragments. The major top and mid-section fragments are marked by “1” and the major bottom trunk fragment by “4”, respectively. The area surrounding the fir was peppered with debris of various size. At the base of the fir only an about 3 m high thin stub remained, while major parts of the roots were blasted away leaving a crater about 70 cm deep (Fig.1).

Figure 1: Remnant stub with the top fir fragment just behind

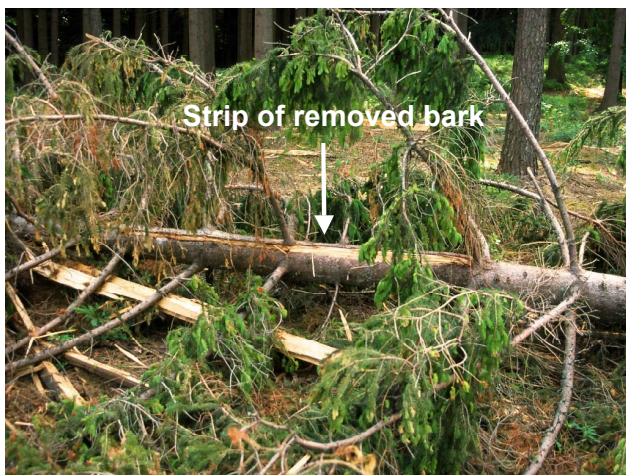
Figure 2 shows the major top fir fragment in detail. An about 5 cm wide sheet of the bark is removed at a length of about 2,1 m. Such sheets of stripped off bark are typical for trees struck by lightning.

Figure 2: Major top fir fragment showing a strip of removed bark by the lightning current

Generally, the specific weight of the fragments was comparatively low and the wood pretty dry. At the fragments and the splinters no scorch marks could be found. Also no scorch marks could be detected at the trunk surface, where the strip of bark was removed (Fig. 2). These observations are in concordance to the report of *Norinder* (see above).

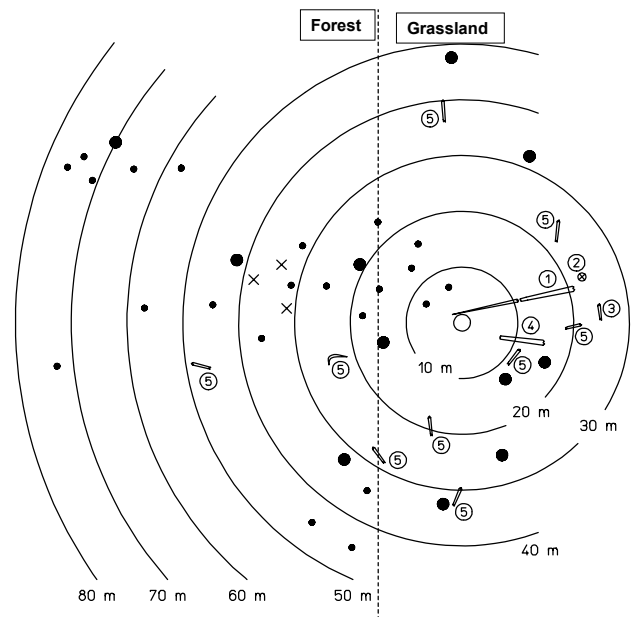
Figure 3: Location of fragments with a weight of > 1 kg around the damaged fir

Figure 3 shows the distribution of the fragments around the fir. The numerous small splinters and fragments with weights less than 1 kg are disregarded. About 10 fragments weighing between 20 kg and 70 kg were found in distances of up to 50 m around the fir. More than 10 smaller fragments between 10 kg and 20 kg were located in distances of up to 70 m from the fir. Smaller fragments between 1 kg and 10 kg were blasted over distances of up to 80 m.

Most of the larger fragments were found on the grassland (see Fig. 3). Figure 4 shows an about 3 m long fragment sticking like a spear in the grassland about 23 m away from the fir (see number 2 in fig. 3).

- 1: Top fir and mid-section fir fragments (total length about 24 m)
- 2: Spear shape fragment of the trunk (~ 3 m length)
- 3: Trunk segment of more than 100 kg weight
- 4: Major base trunk fragment (1/3 of the trunk diameter, ~ 8 m length)
- 5: Trunk segments of 20 ... 70 kg
- Trunk or root segments of 10 ... 20 kg
- Trunk or root segments of 1 ... 10 kg
- X Remote trees with large patches of removed bark (more than 30 m distance)

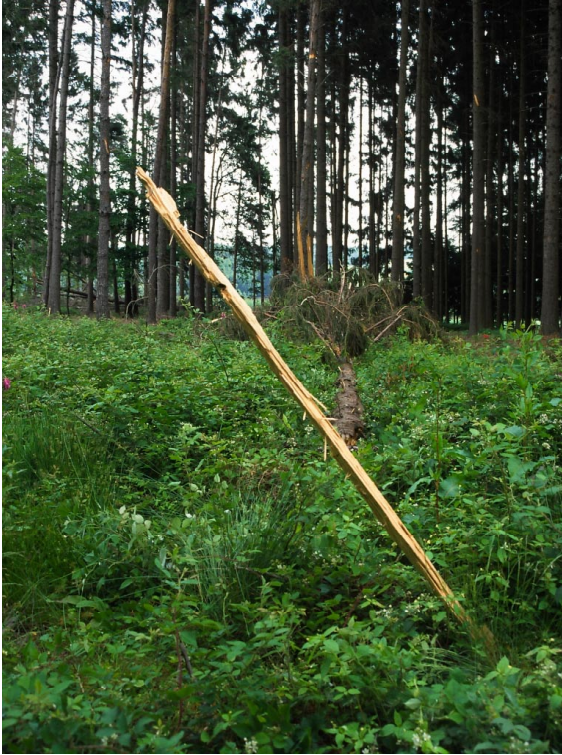
Figure 4: Spear shape fragment of the trunk (~ 3 m length)

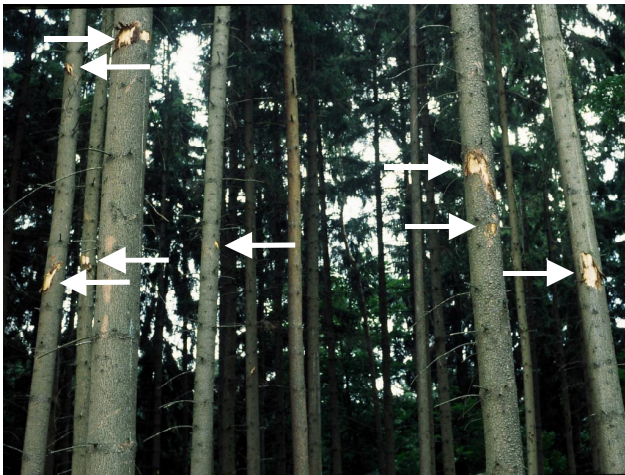
Opposite, the smaller fragments were preferably blasted towards the forest. The explosion was so intense, that at more than 10 surrounding trees large patches of the bark were removed obviously by fragments hitting them with high speed (Fig. 5). Even at three trees in distances of more than 20 m large bark patches were missing (see "X" in fig. 3). E.g. in a distance of about 23 m a tree was found, with a nearly 1 m² patch of bark missing at a height of about 18 m.

Figure 5: Trees with bark damages marked by arrows

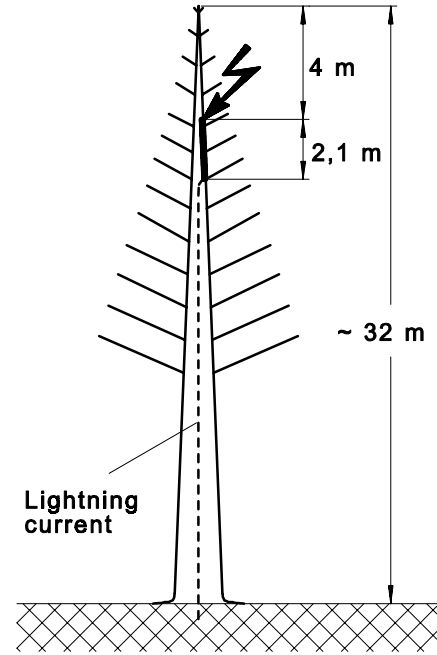
Fig. 6 shows the reconstruction of the current paths along and through the fir. The lightning current attached the bark about 4 m below the top. From there, the current obviously flew just below the bark stripping off the above mentioned sheet of bark (about 5 cm wide and about 2,1 m long). At the height of about 26 m a hole was found, where obviously the current entered the trunk. The current then flew internally through the trunk to the roots, where it entered the ground. At this transition to ground probably the earth resistance was too high resulting in arcing at the roots. These arcs may be the reason, why the trunk and major parts of the roots were blasted away, leaving the 70 cm deep crater.

Figure 6: Schematic sketch of the lightning current path

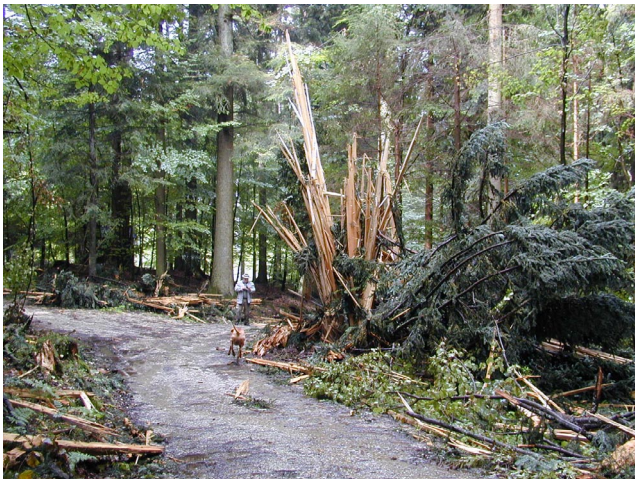
Fig.7 shows the remaining stub splintered down to the ground level. Pieces of different size and weight were found at distances of up to 30 meters. We have to note that this tree was surrounded by other trees of similar height in all directions and therefore we have to assume that the pieces did hit surrounding trees. Also in this case the top section of the tree was more or less intact (wood was not splintered) showing scorch marks on the surface (Fig.8).

Figure 7: Remnant, splintered stub of a fir tree of about 100 cm diameter (Photo courtesy of C. Kretz)

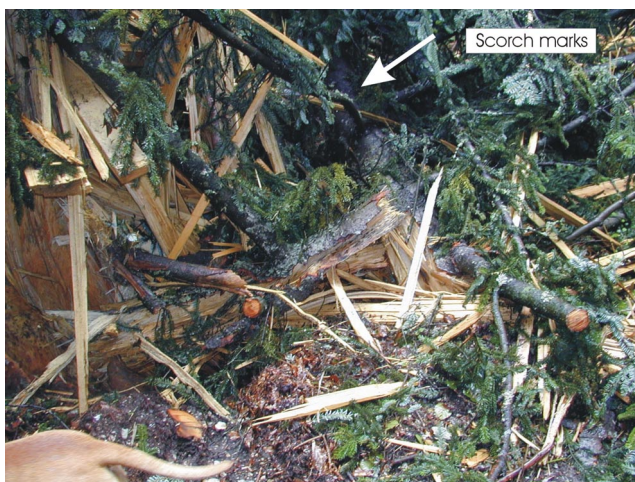
Figure 8: Top section of the tree showing scorch marks (Photo courtesy of C. Kretz)
