EXAMPLES OF TREES SEVERELY DESTROYED BY LIGHTNING

F. Heidler⁺, G. Diendorfer^{*}, W. Zischank⁺

ABSTRACT

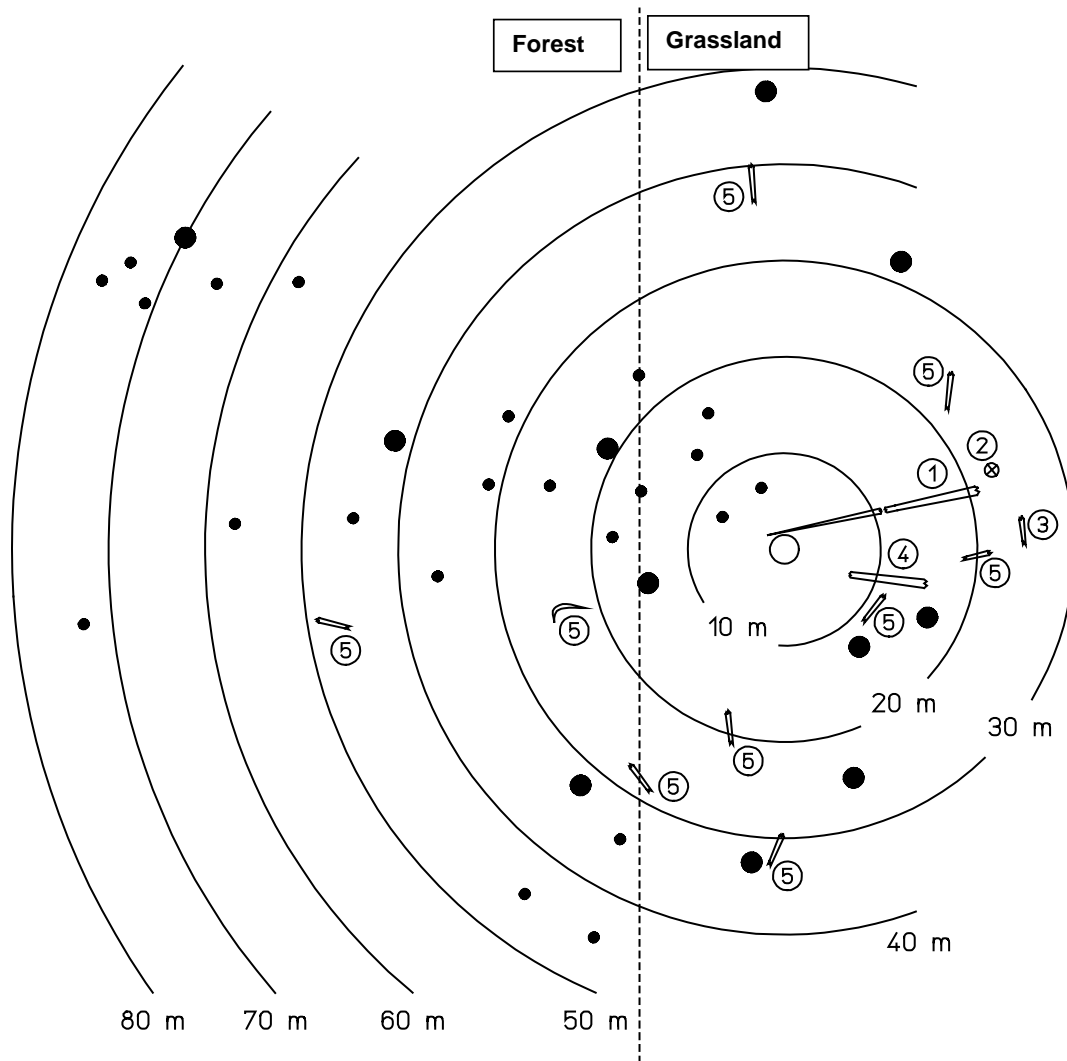
Figure 1: Location of fragments with a weight of > 1 kg around the damaged fir

- 1: Top fir and mid-section fir fragments (total length about 24 m)
- 2: Spear shape fragment of the trunk (~ 3 m length)
- 3: Trunk fragment of more than 100 kg weight
- 4: Major bottom trunk fragment (1/3 of the trunk diameter, ~ 8 m length)
- 5: Trunk segments of 20 ... 100 kg
- Trunk or root segments of 10 ... 20 kg
- Trunk or root segments of 1 ... 10 kg

In figure 1, the numerous small splinters and fragments with weights less than 1 kg are disregarded. The major top and mid-section fragments are marked by “1” and the major bottom trunk fragment by “4”, respectively. Other fragments with remarkable size are numbered by “2”, “3” and “5”, while smaller fragments with weights between 1 kg and 20 kg are denoted by dots.

When a tree is cut, typically the top of the tree is farthest away from the stump. Opposite to that, here the top fir segment was located closest to the stump fragment. The major bottom fir segment was blasted away about 16 m and the major mid-section fir fragment more than 20 m, respectively. Remarkably, the upper parts of these fir fragments pointed towards the remnant stub (Figure 1).

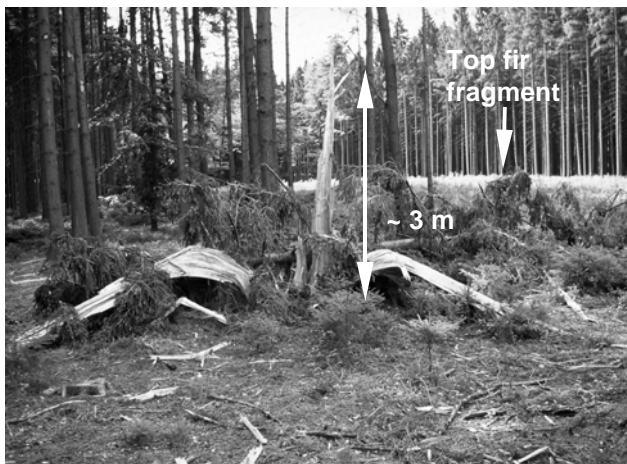
Figure 2 shows the area surrounding the fir peppered with debris of various size. At the base of the fir only an about 3 m high thin stub remained, while major parts of the roots were blasted away leaving a crater about 70 cm deep. Parts of the roots were found even in distances of several ten meters, e.g. a root fragment of about 40 kg was located in about 40 m distance. These very severe destructions corroborate, that the trunk and the root violently exploded.

Figure 2: Remnant stub with the top fir fragment just behind

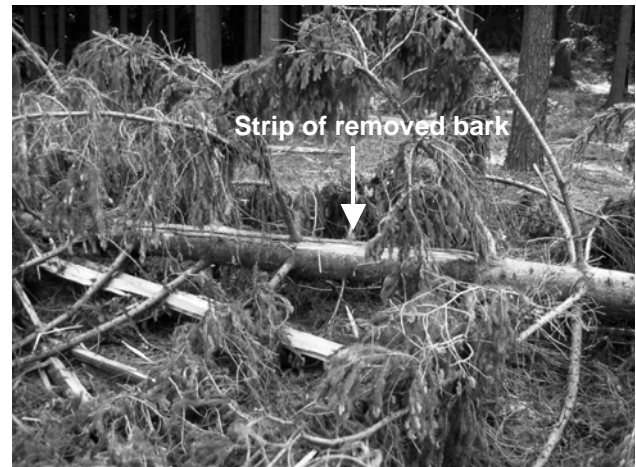
Figure 3 shows the major top fir fragment in detail. The top section of the tree was more or less intact and wood was not splintered, but an about 5 cm wide sheet of the bark is removed at a length of about 2,1 m. Such sheets of stripped off bark are typical for trees struck by lightning.

Figure 3: Major top fir fragment showing a strip of removed bark by the lightning current

Generally, the specific weight of the fragments was comparatively low and the wood pretty dry. At the fragments and the splinters no scorch marks could be found. Also no scorch marks could be detected at the trunk surface, where the strip of bark was removed (Figure 3). These observations are in concordance to the report of **Norinder** (see above).

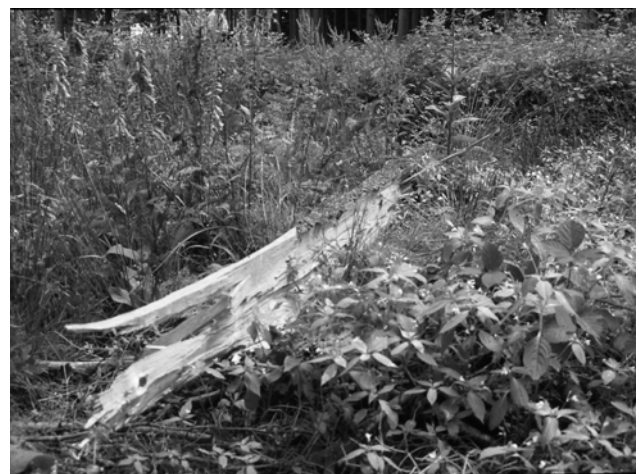
Figure 4 shows an example for the numerous trunk fragments. About 10 fragments weighing between 20 kg and 100 kg were found in distances of up to 50 m around the fir. More than 10 smaller fragments between 10 kg and 20 kg were located in distances of up to 70 m. Smaller fragments between 1 kg and 10 kg were blasted over distances of up to 80 m (see figure 1).

Figure 4: Trunk fragment in the grassland between flowers

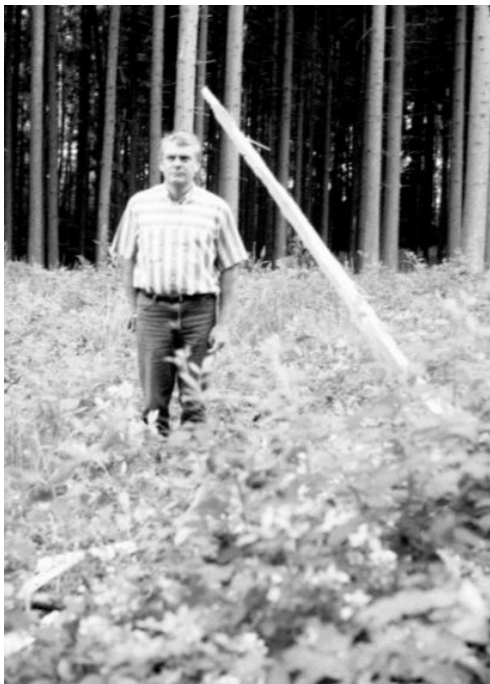
Most of the larger fragments were found on the grassland (see Figure 1). Figure 5 shows an about 3 m long fragment sticking like a spear in the grassland about 23 m away from the fir (see number 2 in figure 1).

Figure 5: Spear shape fragment of the trunk (~ 3 m length)

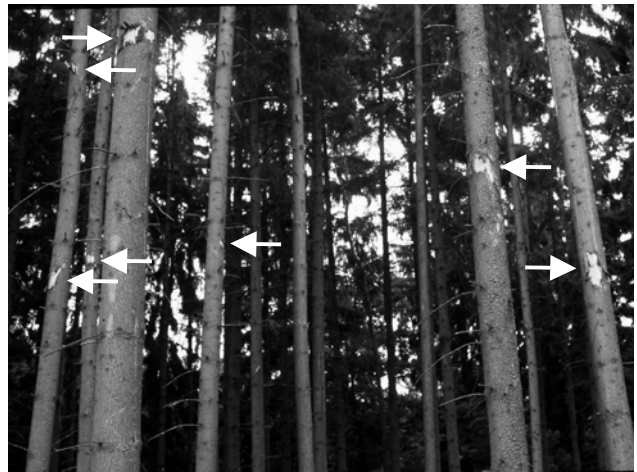
Opposite, the smaller fragments were preferably blasted towards the forest. The explosion was so intense, that at more than 10 surrounding trees large patches of the bark were removed obviously by fragments hitting them with high speed (Figure 6).

Figure 6: Trees with bark damages marked by arrows

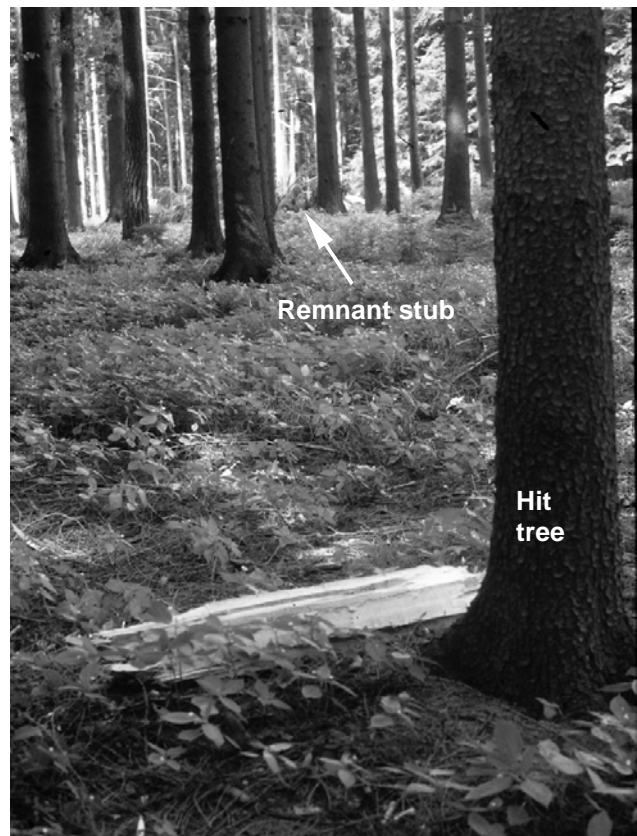
Even at three trees in distances of more than 20 m large bark patches were missing. For instance, in a distance of about 23 m a tree was found, with a nearly 1 m² patch of bark missing at a height of about 18 m. Obviously a fragment of more than 10 kg hit the tree with high speed. Figure 7 shows this fragment located just in front of the hit tree.

Figure 7: Trunk fragment in front of the hit tree

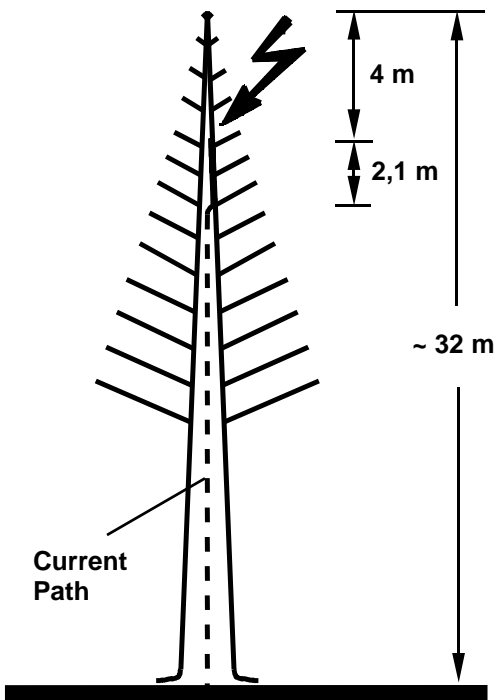
Figure 8 shows the reconstruction of the current paths along and through the fir. The lightning current attached the bark about 4 m below the top. From there, the current obviously flew just below the bark stripping off the above mentioned sheet of bark (about 5 cm wide and about 2,1 m long).

At the height of about 26 m a hole was found, where obviously the current entered the trunk. The current then flew internally through the trunk to the roots, where it entered the ground. At this transition to ground probably the earth resistance was too high resulting in arcing at the roots. These arcs may be the reason, why the trunk and major parts of the roots were blasted away, leaving the 70 cm deep crater.

Figure 8: Schematic sketch of the lightning current path

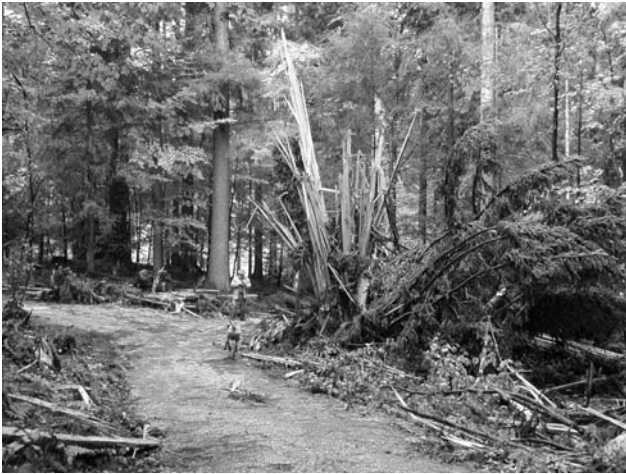
Figure 9 shows the remaining stub splintered down to the ground level. Pieces of different size and weight were found at distances of up to 30 meters. We have to note that this tree was surrounded by other trees of similar height in all directions and therefore we have to assume that the pieces did hit surrounding trees. Also in this case the top section of the tree was more or less intact (wood was not splintered) showing scorch marks on the surface (Figure 10).

Figure 9: Remnant, splintered stub of a fir tree of about 100 cm diameter (Photo courtesy of C. Kretz)

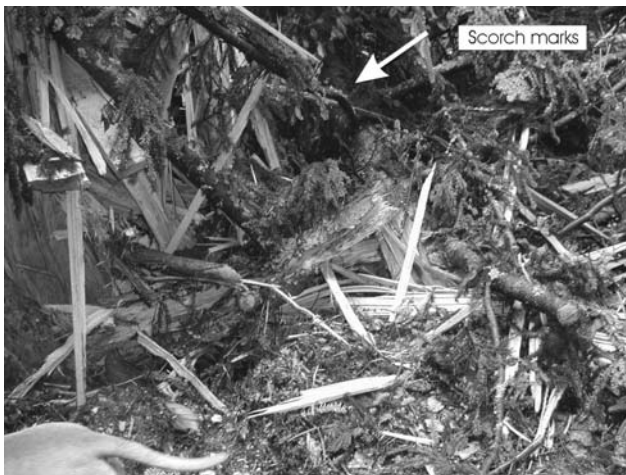
Figure 10: Top section of the tree showing scorch marks (Photo courtesy of C. Kretz)
