# Current measurements of upward leaders from buildings

**Abstract**—Although there are some data on lightning attachment to tall towers (height over 60 m), there are no observational data of lightning attachment to common structures or buildings (under 60 m) that are present in almost every city. In this paper we analyze current measurements of upward leaders induced by a downward negative lightning flash that struck a building located in São Paulo, Brazil. The attachment process was recorded by two high-speed cameras running at 37,800 and 70,000 images per second, two current sensors and an electric field sensor.

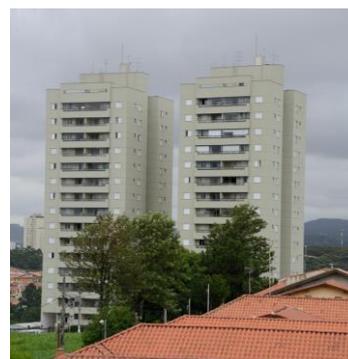
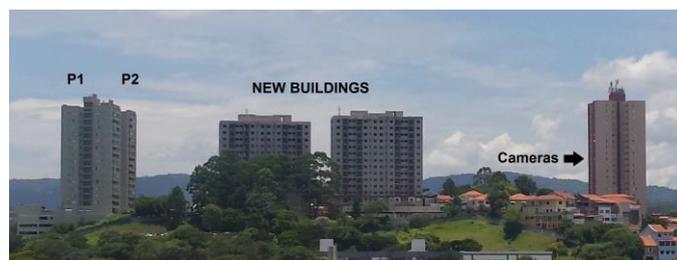
Fig. 1. a) Identical 14-story apartment buildings (P1 on the left and P2 on the right); b) Location of the cameras (210 m from P1 and P2).

In order to observe lightning attachment to common buildings, two high-speed video cameras, a still camera and two standard video cameras were positioned at a distance of 210 m from a pair of identical 14-story apartment buildings, named P1 and P2 (see Fig. 1), located in São Paulo City (23.483°S, 46.728°W), Brazil. Their steel reinforced concrete structures are used as natural LPS. Each building has a vertical lightning rod, and their tips are at a height of 52 m respective to ground floor.

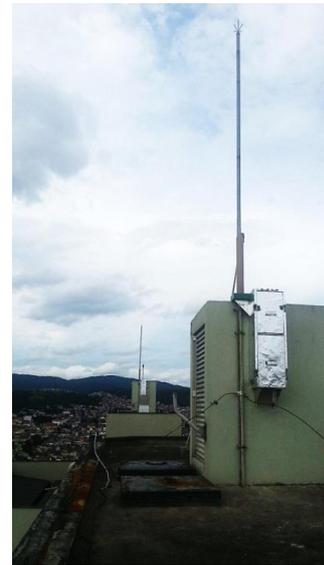
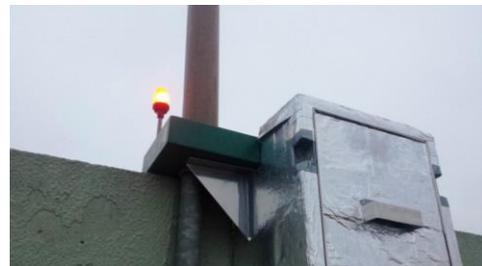
Fig. 2. Current sensors installed on the lightning rods of buildings P1 and P2 (upper picture) and detail of the installation (lower picture).

One Pearson current sensor model 301-X was installed on the lightning rod of each building (see Figure 2). This current sensor is capable of recoding current up to 50,000 A with an useable rise time of 200 nanoseconds, a low frequency 3 dB cut-off of 5 Hz (approximate) and a high frequency 3 dB cut-off of 2 MHz (approximate). The output of the sensor is split in two channels (20 dB and 50 dB attenuation over 50 Ω), and sent to a data acquisition system through a pair of fiber optic links. Before installation, both sensors were tested and calibrated in the high voltage facility at IEE/USP.

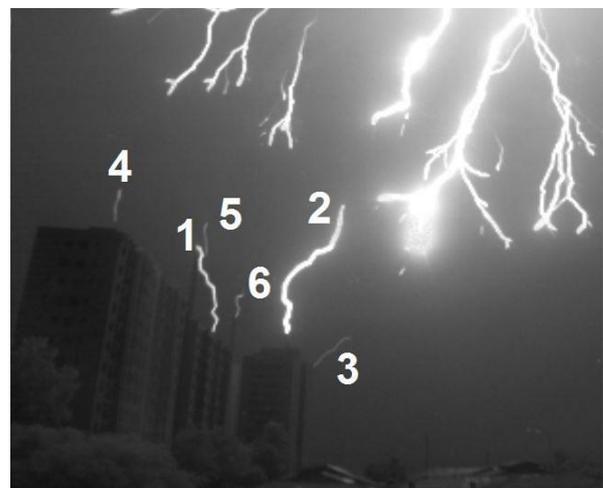
Fig. 3 – UCL from P2 (number 2), and UULs (numbers 1, 3, 4, 5 and 6) from the mast of P1, the side of P2, and from other buildings nearby (see Fig. 1).

lightning rod on building P2 together with UULs from the vertical air-termination rod of the other building (P1) and other nearby structures, as shown in Fig. 3. The leaders (numbered 1 to 6 in Fig. 3) have their origin at different distances from the electric field sensor. The distances and leader types are shown in Table 1.

Origin of the leader	Leader number in Fig. 3	Leader type	Distance from the electric field sensor
P1 vertical mast	1	UUL	22.5 m
P2 vertical mast	2	UCL	4.0 m
P2 right corner	3	UUL	14 m
New building (corner)	4	UUL	141 m
New building (construction elevator 1)	5	UUL	105 m
New building (construction elevator 2)	6	UUL	63 m
