# Current measurements of upward leaders from buildings

**Abstract**—Although there are some data on lightning attachment to tall towers (height over 60 m), there are no observational data of lightning attachment to common structures or buildings (under 60 m) that are present in almost every city. In this paper we analyze current measurements of upward leaders induced by a downward negative lightning flash that struck a building located in São Paulo, Brazil. The attachment process was recorded by two high-speed cameras running at 37,800 and 70,000 images per second, two current sensors and an electric field sensor.

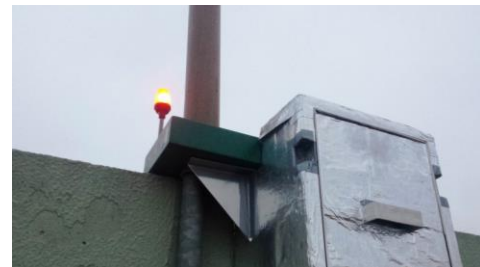
Fig. 2. Current sensors installed on the lightning rods of buildings P1 and P2 (upper picture) and detail of the installation (lower picture).

One Pearson current sensor model 301-X was installed on the lightning rod of each building (see Figure 2). This current sensor is capable of recoding current up to 50,000 A with an useable rise time of 200 nanoseconds, a low frequency 3 dB cut-off of 5 Hz (approximate) and a high frequency 3 dB cut-off of 2 MHz (approximate). The output of the sensor is split in two channels (20 dB and 50 dB attenuation over 50 Ω), and sent to a data acquisition system through a pair of fiber optic links. Before installation, both sensors were tested and calibrated in the high voltage facility at IEE/USP.

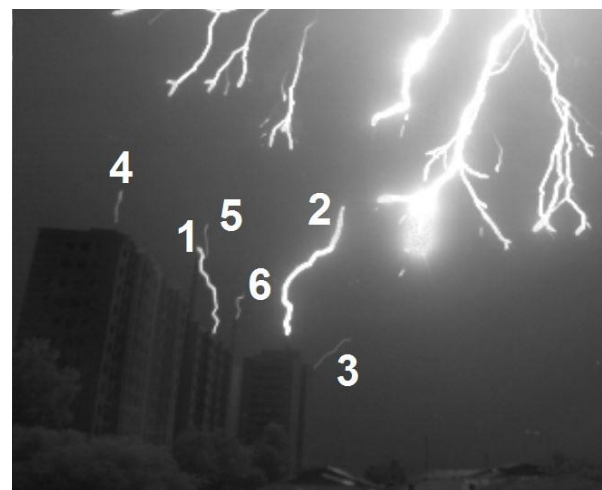
Fig. 3 – UCL from P2 (number 2), and UULs (numbers 1, 3, 4, 5 and 6) from the mast of P1, the side of P2, and from other buildings nearby (see Fig. 1).

lightning rod on building P2 together with UULs from the vertical air-termination rod of the other building (P1) and other nearby structures, as shown in Fig. 3. The leaders (numbered 1 to 6 in Fig. 3) have their origin at different distances from the electric field sensor. The distances and leader types are shown in Table 1.

Origin of the leader	Leader number in Fig. 3	Leader type	Distance from the electric field sensor
P1 vertical mast	1	UUL	22.5 m
P2 vertical mast	2	UCL	4.0 m
P2 right corner	3	UUL	14 m
New building (corner)	4	UUL	141 m
New building (construction elevator 1)	5	UUL	105 m
New building (construction elevator 2)	6	UUL	63 m
