Recent Observations of Lightning Strikes to Wind Turbines and Railway Overhead Lines

SUMMARY

This paper presents recent analyses of lightning observations in the Austrian Alps gathered by Graz University of Technology in cooperation with the Austrian Lightning Detection and Information System (ALDIS). The project “Lightning Observation in the Alps – LiOn” was initiated in 2017 to record ground truth data of atmospheric discharges in the Alpine region. Atmospheric discharges were observed at 21 different measurement locations using a Video and Field Recording System (VFRS). This system consists of a high speed video camera (2000 frames per second) and a flat plate antenna to measure the electric field. Both, the camera and the electric field measurement system, are synchronized with GPS time and can therefore be correlated with Lightning Location System (LLS) data.

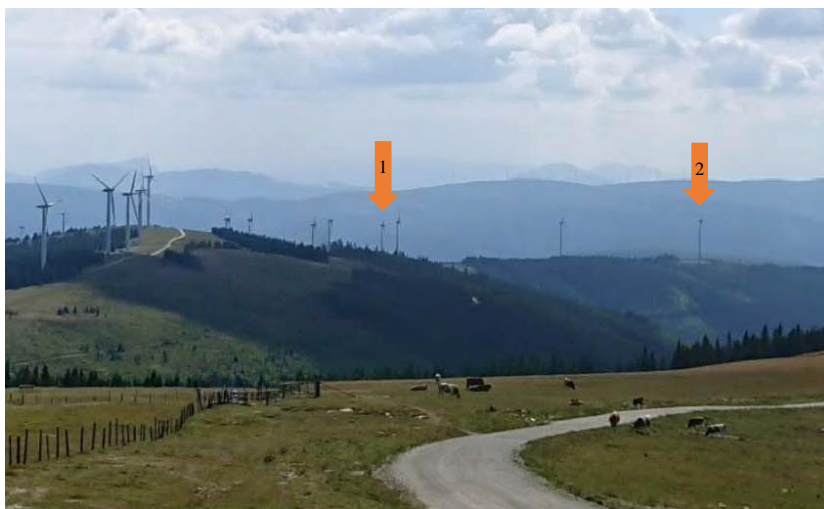
Figure 1: Wind farm on a pre-alpine mountain ridge (ca. 1450 m a.s.l.); Stroked wind turbines 1 and 2 highlighted; © Google Maps

The wind turbines of case 1 are parts of a wind farm comprised 21 generators situated on a mountain ridge with a height of about 1450 m above sea level. Each of these three-bladed wind turbines has a maximum height of around 120 m and a nominal power of 2.6 kW. The wind farm is shown in Fig. 1. The recorded flash consists of four strokes. Three strokes hit one turbine (first stroke one (FI1) and two subsequent strokes (SU1) within the same channel) and the fourth stroke (FI2) followed a new channel and hit a second wind turbine. A downward stepped leader is visible in the video before the first return stroke. Also for the fourth stroke a downward stepping process is visible. All four strokes have been detected by the LLS. A correlation of the VFRS data and the LLS data is possible because of the used GPS time. The installed relays in each wind turbine are synchronized to server time (time resolution seconds) but no other event was recorded for the wind farm on that day.

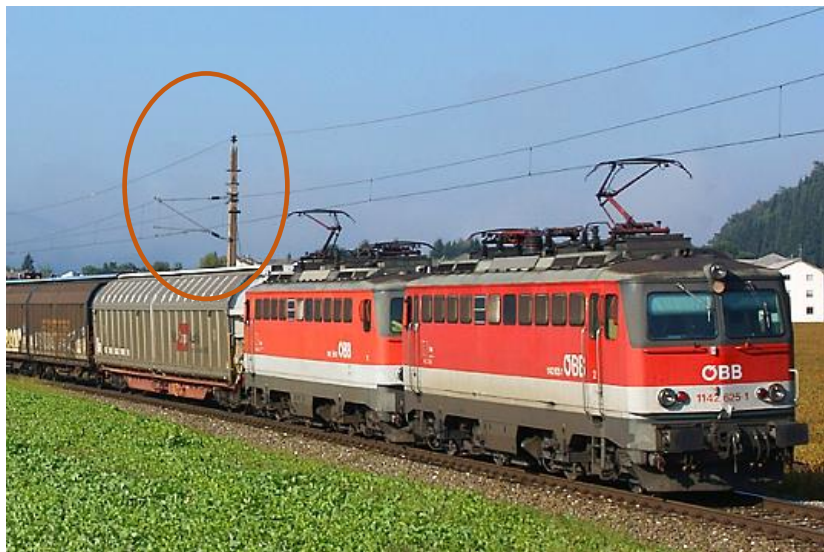
Figure 2: Railway overhead track in the analyzed section; Tower structure highlighted; © Markus Hipfl, bahnbilder.warumdenn.net

The railway overhead line in the analyzed section consists of a phase wire, mounted on top of concrete towers, and the feeder in the height of the pantograph. The Austrian railway system is operated as a single phase system and the railway track is used as return conductor. The line, operating on a voltage level of 15 kV and a frequency of 16.66 Hz, is connected to two substations. Digital protection relays and inductive instrument transformers are installed in both substations. Fig. 2 shows a section of the analyzed track. No train was on the track section in the moment of the lightning strike.

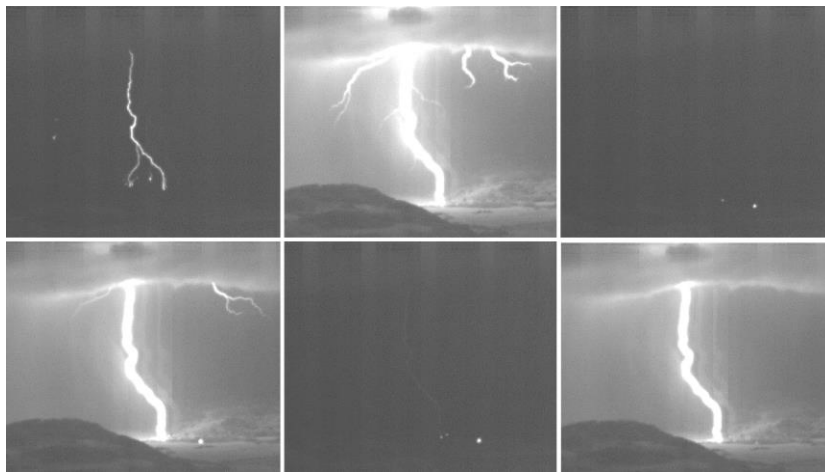
Figure 5: Stepped leader, first return stroke (FI1), flashover on two towers, subsequent stroke 2 (SU1), flashover on three towers and subsequent stroke 3 (SU1) from top left to bottom right; © LiOn IHS TU Graz 2019

For case two, a correlation of VFRS and LLS data with distance protection relay fault records of the Austrian railway operator was possible. Six frames of the high speed video of this case are shown in Fig. 5. The negative flash, including all three strokes, was correctly detected by the LLS. The start time of the short circuit in the digital fault record correlates with the LLS time of the first stroke (timestamp accuracy of distance protection relay in ms). Stroke one to three had a calculated current of -4 kA to -10 kA. All three strokes hit the same tower (same GSP visible in the video). These three strokes were located in a distance range of 81 to 1424 m from this tower. The data of the LLS and the distance of the calculated location to the tower is shown in Table 2. The first stroke caused a flashover, visible in the video for 79 ms, on the affected tower and on two other towers. For this reason, a direct impact on the overhead line can be assumed. After 46 ms the line was tripped and after 123 ms the whole fault handling was closed by the distance protection relay. No transient signal changes, caused by atmospheric discharges, were detected in the digital fault records because of the low sampling rate of the protection relay (20 samples per period) and the used inductive instrument transformers. They are installed to generate an image of the 16.66 Hz component for measurement and protection purposes. The locations of the railway track, LLS detections and 50 % confidence ellipses of the strokes are shown in Fig. 6. The data of the LLS and the distances of the calculated locations are given in Table 2.
